Minimize Downtime and Costly Repairs with the Use of Temperature Tracking

*Elizabeth R. Patterson
United States Steel Corporation*

Keywords: steel, blast furnace, upper assembly, refractory, predictive maintenance

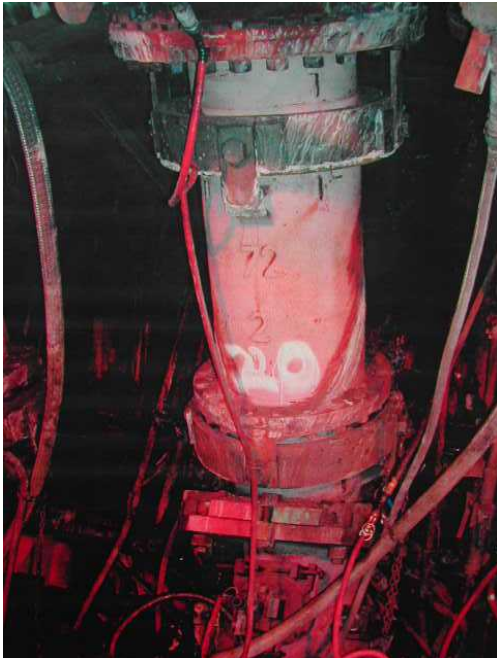
Figure 4. Blast furnace gimbal expansion joint

The gimbal expansion joint is designed in such a way as to allow for some rotation to compensate for the movement of the bustle pipe. This rotation, however, has at times caused the overlapping vacuum-formed insulation – a colloidal silica binder – within the gimbal joint to be compressed to a point that it cannot regain its original shape (Fig. 5). The over-compressing of insulation creates a gap between the refractory and the upper assembly shell. This insulation gap then allows hot air to heat up the upper assembly shell, and the insulation begins to break down, leaving behind a sand-like material.

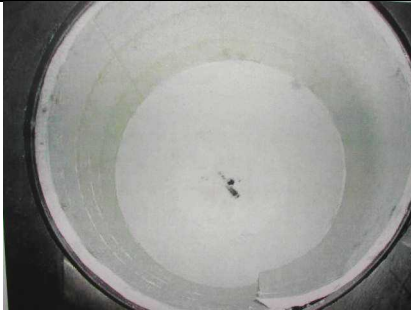
Figure 5. Overlapping vacuum formed insulation

Another change was made to the insulating material within the gimbal expansion joint. The original design allowed for an overlap of refractory material (Fig. 5). The concern was that while installing the plug in the expansion joint, the material could move, causing a gap at the overlap. Or it could slip down and leave a gap, thus allowing air to pass through the body of the upper assembly. It would be like putting your sock in your shoe and then trying to put your foot in the sock. New cylinder and bowl gaskets were designed that consisted of silica/glasswool fibers enclosed in a high-temperature cloth. The cylinder gasket was then stitched to the bowl gasket using high temperature thread. The new design was a custom-fit sleeve, resembling a toeless sock, that could better handle the rotation of the gimbal expansion joint and high temperatures (Fig. 12, 13).

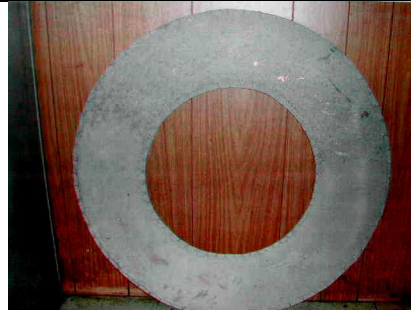
Figure 6. Ceramic fiber gasket

Hot air can also get under the ceramic fiber gasket and cause the bustle pipe flange and the upper assembly flange to develop hot spots (Fig. 6). Once this occurs, no repairs can be made to the upper assembly while the furnace is operating. The furnace must be taken off-line, the upper assembly completely removed and replaced with a new one, and the old one sent out of the plant for repairs. Removing and replacing the upper assembly can take anywhere from 3 to 6 hours. Lost production time, along with the repairs, can be very costly.

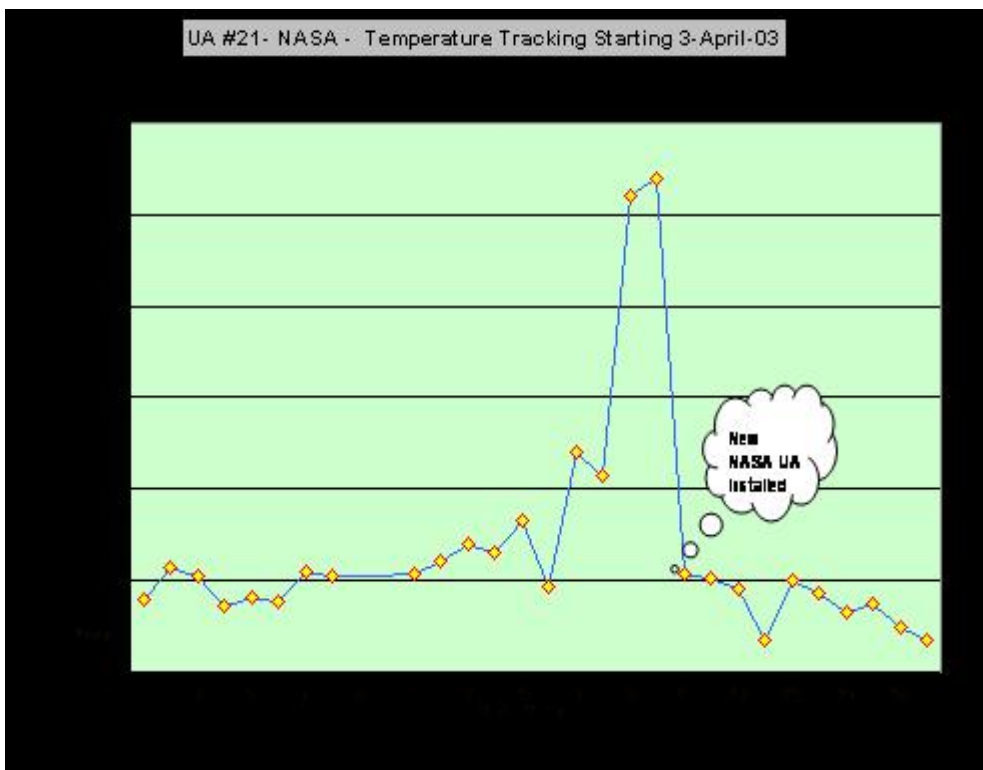
Figure 7. Temperature tracking of upper assembly hot spot progression

From the numbering system, certain patterns have been noticed. Hot spots found on the lower and upper bellow of the upper assembly would appear and disappear, due to the rotation of the upper assembly and change in operating conditions. But those found on the upper flange remained constant and only increased in size and temperature over time. For example, an upper assembly could have a temperature of 800°F on the lower bellow one week and then be under 700°F the next week. However, if the upper flange had a temperature of 800°F, it would either remain this hot for a few weeks, or the temperature would increase with each scan. Eventually, the upper flange area would begin to glow. At this point, the upper assembly would be removed from service as soon as possible.

The most common problem areas were above and below the two gimbal expansion joints and the upper flange of the upper assembly connecting to the bustle pipe flange. The information collected and stored in the spreadsheets helped Research and Development make changes to the design of the upper assembly.

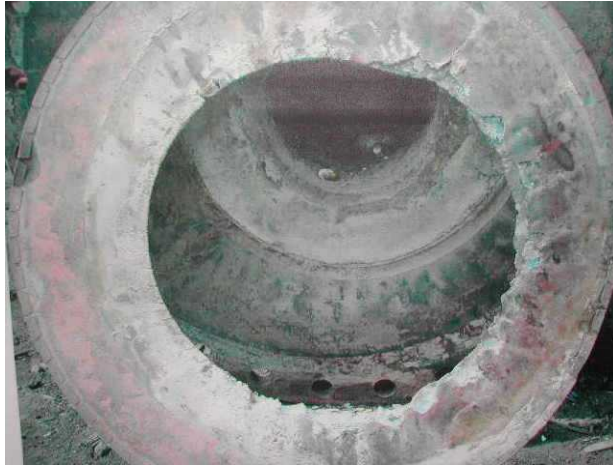
Figure 9. Partially destroyed upper assembly flange gasket

While changing an upper assembly as a result of temperatures exceeding 1100°F on the upper flange, it was discovered that the flange gasket had been partially destroyed (Fig. 9).

This is believed to be the result of the gasket not being rated to handle the high temperatures coming from the bustle pipe to the upper assembly. Even though changing the upper assembly and installing the properly rated gasket did lower the temperature in this area, it did not completely solve the problem. For example, upper assembly #30 had been changed four times in just less two years because of the same problem. Within weeks of installation the upper flange area was already exceeding the trigger temperature. A field inspection of the last failed upper assembly #30 was performed, and the following discrepancies were found: the flange gasket was sitting 2" from the front edge of the upper assembly, overlapping the bolt holes; and a burn pattern was clearly visible (Fig. 10). In addition, the flange gasket was sitting 4¾" from the back edge of the upper assembly, and no burn marks were noted (Fig. 11).

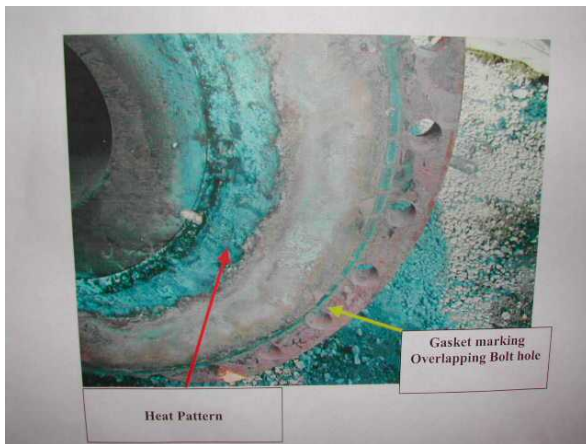
Figure 10. Burn pattern on flange gasket

While observing the installation of the new upper assembly, it was noted that positive positioning of the gasket could not be obtained. Because the gasket was smaller than the flange area, it could shift out of position during the bolting process, which would explain the burn pattern on the failed upper assembly. Recommendations were made to develop a gasket that requires the bolts to pass through it, thereby preventing it from moving out of position. It was also noted during a visual inspection of the bustle pipe flange that there was a 1/16" gap between the ceramic and the material. It took 1½ gallons of grout to fill the void. The recommendation was made to install grout nipples in the bustle pipe flange in order to add more grout, if needed, and monitor the area to see if the added grout would rectify the problem, instead of changing the upper assembly. This procedure was tried on a different upper assembly with the same problem and lowered the temperature on the upper flange from 1077°F to 649°F.

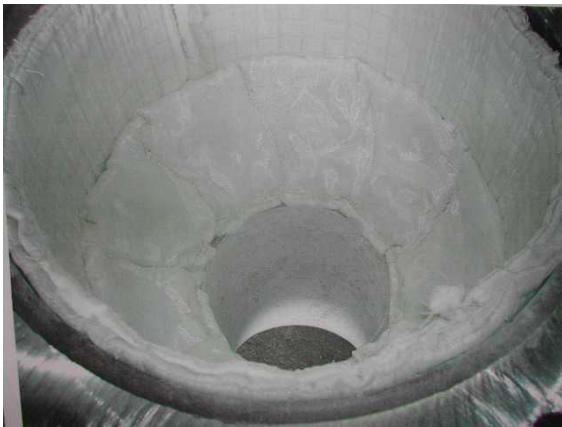
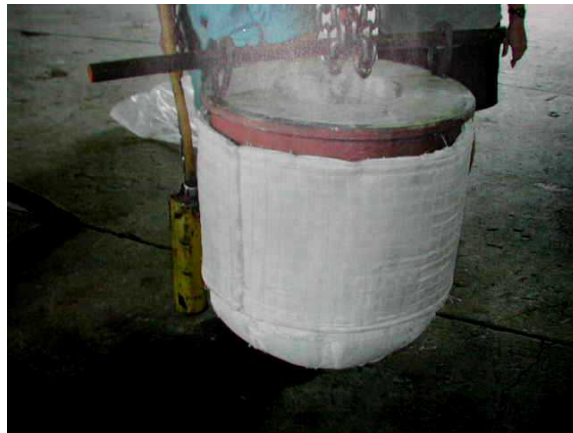
Figure 12. Close-up view of new cylinder and bowl gasket design

Figure 13. Another view of new cylinder and bowl gasket design

This refractory is similar to that used by NASA in the space shuttle, resulting in lower shell temperatures on the upper assembly. While these changes have improved the condition of the upper assembly, they still do not meet our intended goal. As a result of infrared thermography and temperature tracking, a completely new upper assembly is currently being developed for the 2005 rebuild of #13 blast furnace.

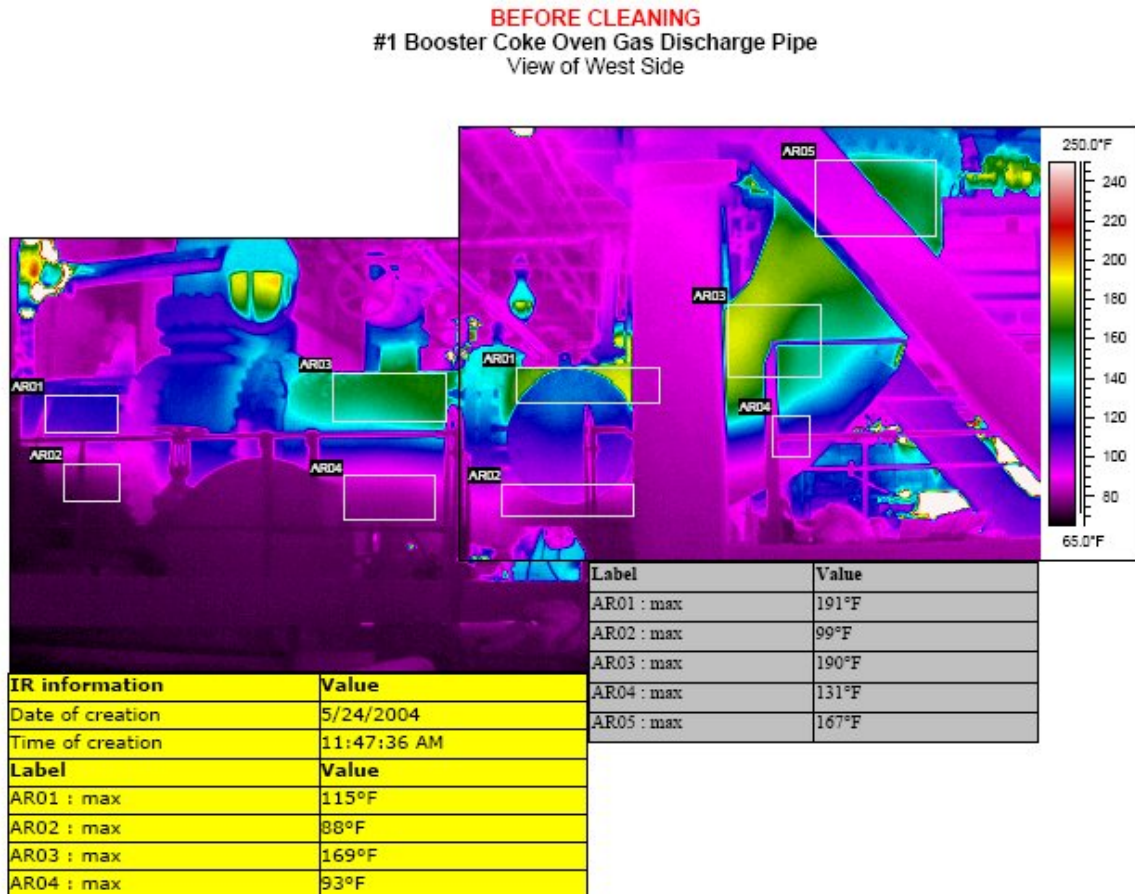
Figure 14. Coke plant thermal image collage of #1 booster coke pump discharge pipe before cleaning (view of west side)

This information is then used for scheduling routine maintenance. We have only scratched the surface with regard to what infrared thermography can do to improve working conditions and productivity within our plant. We can't wait to see what the next year will bring
