# Can your Infrared Camera Find Every Electrical Problem?

Joe DeMonte

Infrared Training Center  
FLIR Systems, Inc.

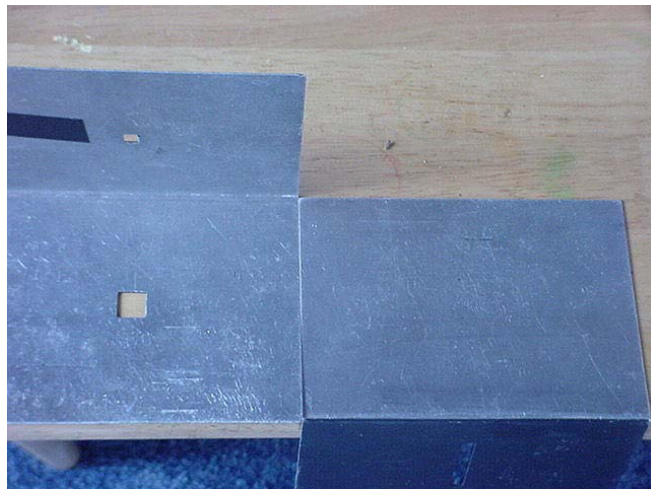
A simple demonstration can show how difficult it can be for even modern IR cameras to find a small temperature difference. The camera I used for the following series is a FLIR Systems Model E2 with a thermal sensitivity of 0.12K and a spectral range of 7.5-13 $\mu$ m. Two aluminum plates of low emissivity, a variable temperature hot plate, and a wooden kitchen table are the props as shown in Figure 1.

Figure 1. A table and two uncoated aluminum plates

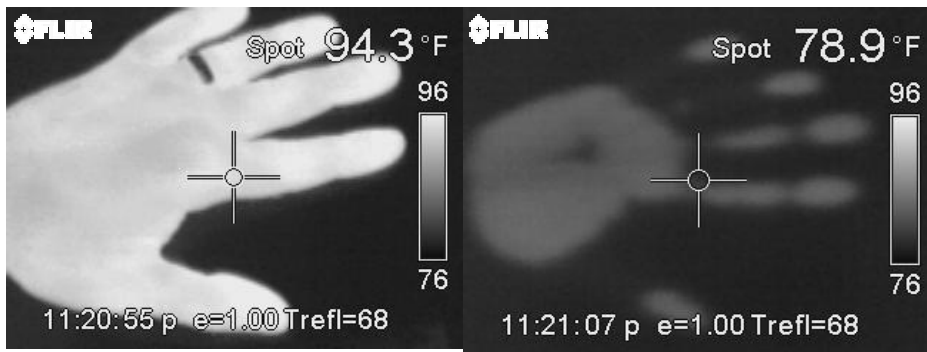
The first example (Figure 2) shows an IR picture of my hand on the table (left) and the heating left behind after touching the table for around five seconds (right). As can be seen, the table has a high emissivity and will show slight temperature changes with good contrast.

Figure 2 Hand on the table (left). Thermal signature of hand on table (right).

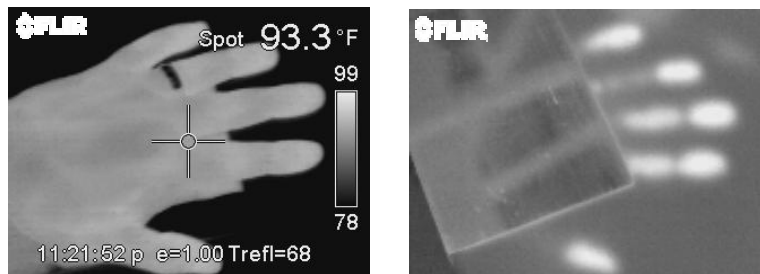
The next part (Figure 3) shows the same hand touching the lower emissivity aluminum plate, and my fingers touching the table simultaneously to show the difference in contrast between the aluminum and table. In the right hand image you can see the rafters of my work shed reflecting off of the aluminum, but can you see any noticeable increase in the thermal signature on the aluminum? The table shows a clear signature, but not the aluminum. Let's do a comparison.

Figure 3. Hand on the aluminum and table (left). Thermal signature of hand on the aluminum and the table (right).

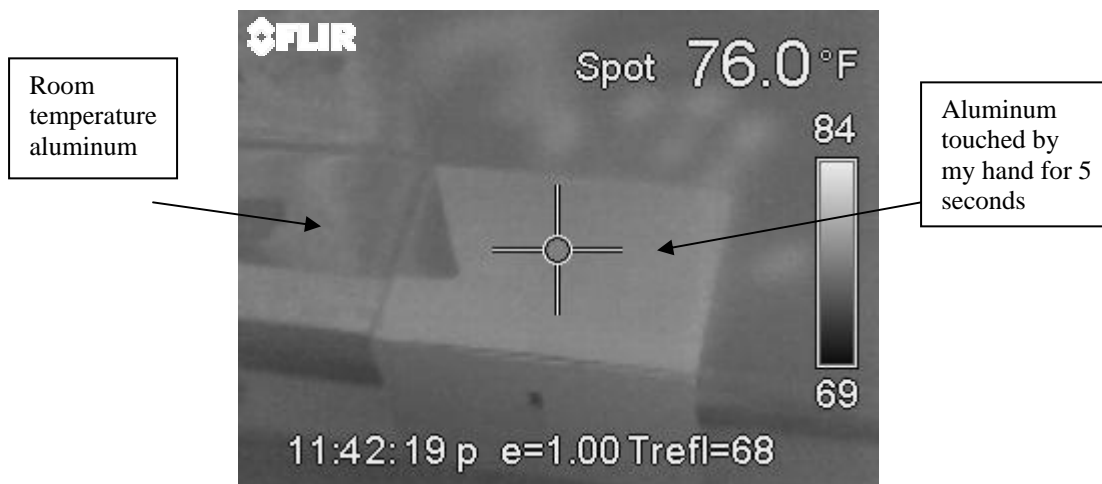
Since every good thermographer lives to compare like objects when determining severity, let's compare two aluminum plates. One plate is kept at room temperature and the other will be touched by my hand (Figure 4). Is there an apparent difference? We know that there is a true temperature difference since my hand was hotter than the aluminum.

Figure 4. Comparison of room temperature plates, one heated by my hand for 5 seconds

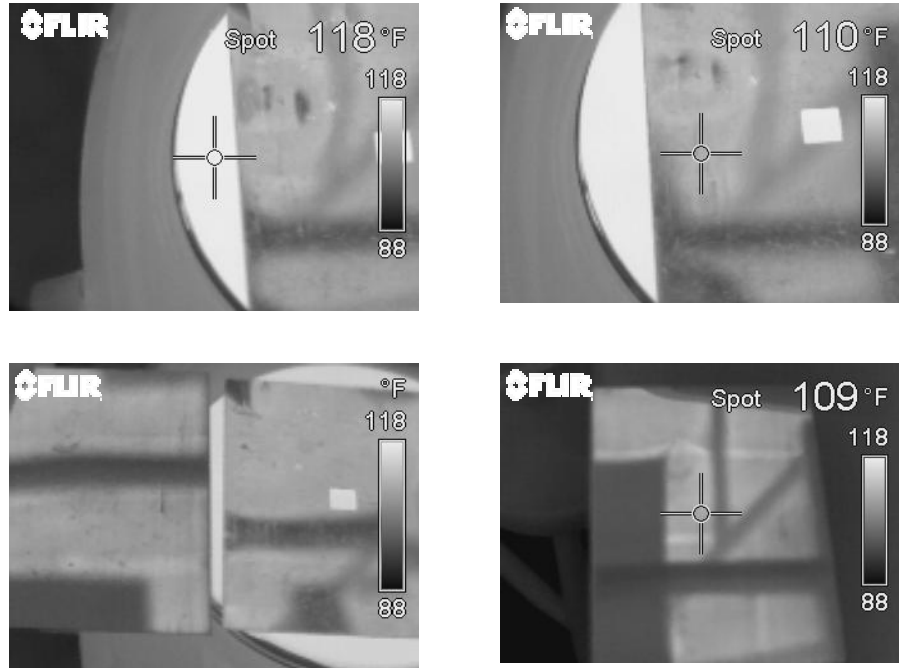
Now let's crank up the heat by using a heating plate on one aluminum plate. I placed the aluminum on a dial controlled heating plate and placed the temperature on low. The IR camera was left with an emissivity of 1.00

to give us the apparent temperature of the heating plate and aluminum (Figure 5, top). A room temperature aluminum plate is then used to compare with the aluminum on the hot plate (Figure 5, bottom).

As we can see, both plates continue to reflect something warm and give a false indication as to what the actual temperatures are. What are they reflecting? We are looking at the reflected radiation from my workshop roof and rafters. The uninsulated roof interior is hot due to heating by the summer sun! Even with a room temperature of 88°F, the aluminum can take on the appearance of being 20F° hotter than actual. There is no perceived difference in temperature between the two pieces of aluminum, even when one is heated to above 118°F. (Note: As we are dealing with temperature differences as well as actual temperatures, we will use °F to indicate temperature and F° to indicate temperature differences.)

Figure 5. Apparent temperature of the hot plate, 118°F (top, left) and the apparent temperature of the aluminum, 110°F (top, right). Room temperature plate compared to the aluminum on hot plate (bottom, left) and the apparent temperature of the room temperature plate, 109°F (bottom, right).

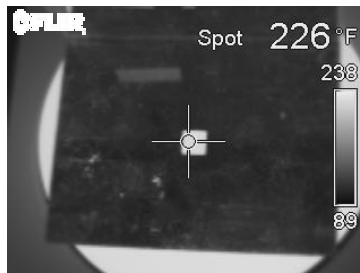
Figure 6.1: Hot plate, apparent temperature, 226°F.

My next step is to heat the uncoated plate further and continue to use the FLIR E2. The following sequence of images (Figures 6.1 through 6.4) shows how low emissivity can throw us off track.

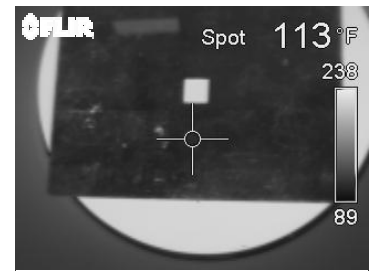
Figure 6.2: Aluminum, apparent temperature, 113°F.

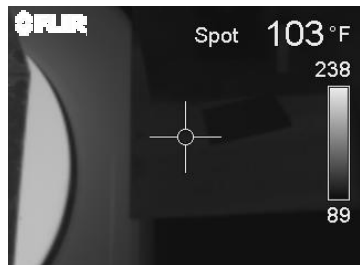
Figure 6.3: Room temperature aluminum, apparent temperature, 103°F

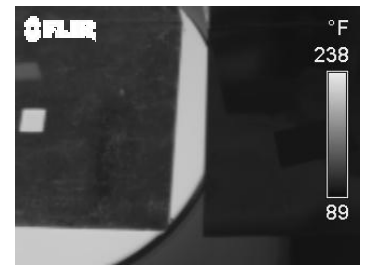
We finally see a “difference” between the two aluminum plates. The problem is that I had to increase the heat and raise the temperature of the aluminum plate by over one hundred degrees Fahrenheit. In Figure 6.4, we can tell that the aluminum plate on the left looks slightly hotter than the one on the right. Imagine these plates to be two aluminum buss bars side by side, and we could say that there is an anomaly present. Comparing the apparent temperatures with our infrared camera (Figure 6.3 and figure 6.2), we see a difference of 113°F minus 103°F, or 10F°. According to most severity criteria, this would be a minor to

Figure 6.4: Comparison of hot aluminum (left) and room temperature aluminum (right)

Our uncorrected difference (rise above similar component) when looking at the aluminum without tape and setting the emissivity to 1.00, was 10F°. Comparing this to the above guidelines puts our measured anomaly in the PROBABLE DEFICIENCY category. Further testing and/or an increased thermal survey monitoring should be the next step. The corrected temperature difference of 106.7F° gives a completely different answer. From Table 1, this

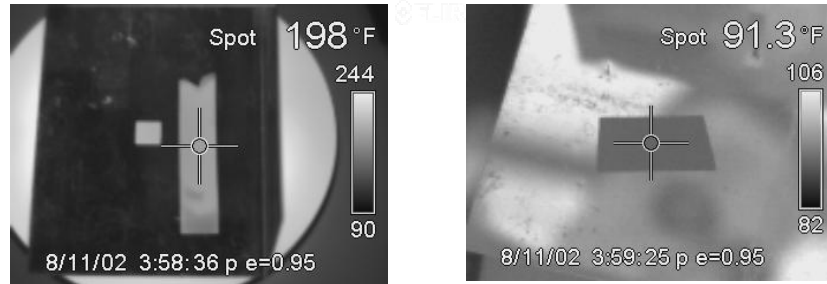
moderate problem. I then placed two strips of black electrical tape on each of the aluminum plates, and dialed the emissivity of the FLIR E2 to 0.95. This should give us a better understanding of what the actual difference in temperature is for the two plates (Figure 7).

The tape on the hot aluminum appears hot to the camera, but the aluminum still looks cool. Amazingly the tape on the room temperature aluminum appears cooler than the aluminum. Why? The aluminum is so reflective it is indicating the hot interior roof temperature of almost 118°F, whilst the tape indicates the actual temperature of only 91.3°F. Our actual temperature difference turns out to be 198°F minus 91.3°F = 106.7°F.

Figure 7. Corrected temperature for the hot plate, 198°F (left) and corrected temperature for room temperature, 91.3°F (right).

The uncorrected difference of 10 F° has an actual corrected value of over 10 times higher! What severity criteria table would call that moderate?

is a MAJOR DISCREPANCY and calls for a REPAIR IMMEDIATELY. Lesson learned: Use only actual, corrected, temperatures to find the temperature rise.

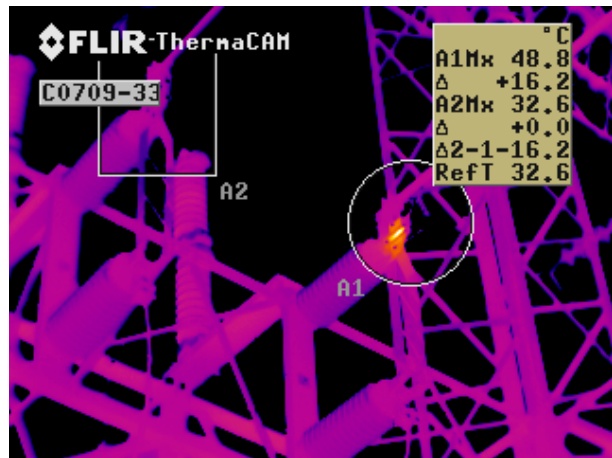
The Severity Criteria table has the right idea. A greater than 4C° rise between two similarly loaded components requires the thermographer to investigate the anomaly further. My experiments show that actual differences of over 100F° are required to make the aluminum “appear” to be only 5C° hotter. Could we use the generic Severity Criteria specs for comparing two electrical components that have a high emissivity? Probably not, as the criteria would end up classifying everything as severe. Take a look at the substation disconnects illustrated in the thermogram of Figure 8.

Using emissivity of 0.9 due to the heavy oxidation on the target, the calculated actual rise in temperature is 16.2C° between the hot connection on the right and the reference connection on the left. This places us in the MAJOR DEFICIENCY category. The thermographer’s field experience shows this disconnect should be classified as a PROBABLE DEFICIENCY, not a CRITICAL or MAJOR DEFICIENCY.

Experience has taught this individual that this is not a serious problem, and he does not have to act on it immediately. The thermogram was taken under no wind, high load conditions. Wind and load play major roles IR surveys. Both can cause the temperature rise to change by factors of 3, 4 or even more. See Madding et al in this proceedings (1). We know that severity criteria exist from all sorts of different organizations and for all sorts of equipment. Most generic Severity Criteria guidelines work well for low emissivity indoor electrical components that are being viewed DIRECTLY. Indirect measurements pose a completely different set of severity criteria (2, 3). My advice is that you should take existing criteria and modify it for your components, or devise your own. Avoid severity criteria based on temperature rise alone. Never use the same set of severity criteria for direct and indirect targets. Lucier gives some good advice on developing severity criteria in his paper (4).

Figure 8. Thermogram of disconnects in a substation.
